Nepal RSK response team provide Standard RSK shelters and blankets for families displaced by Jajarkot earthquake.

BACKGROUND

The Nalgad deployment

The Kushe deployment

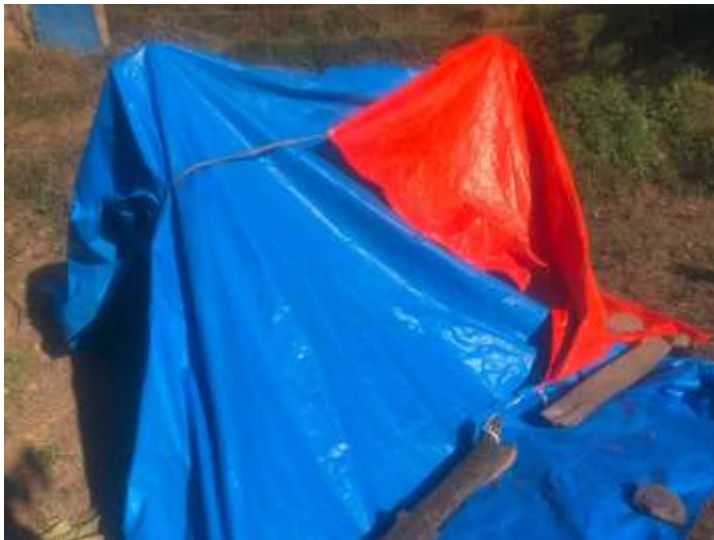
Nalgad 2023

Families were spread over the hillsides and valleys below in various types of makeshift shelters. Most of these shelters were built immediately next to traditional stone walled dwellings that had either collapsed or, more commonly, had still remained standing but suffered severe structural damage and were unsafe to enter. Some of the shelters that displaced families had built were crudely constructed of wood (branches), and bamboo with occasional salvaged CGI sheeting. Many of the shelters were making use of the local orange or blue plastic sheeting supported by either traditional hoops of split bamboo or very basic “A” frame structures. Nearly all these shelters had been hastily built with limited materials and provided the occupants with poor protection for the approaching winter.

Existing poor shelter

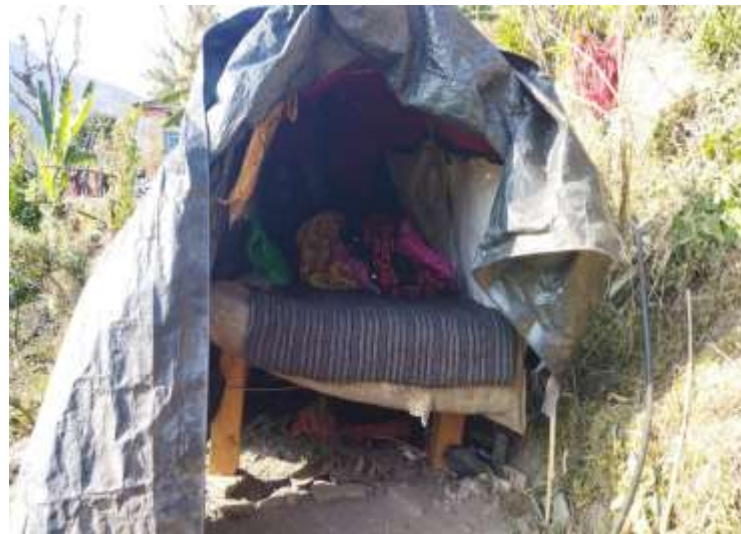
Nalgad 2023

Existing poor shelter

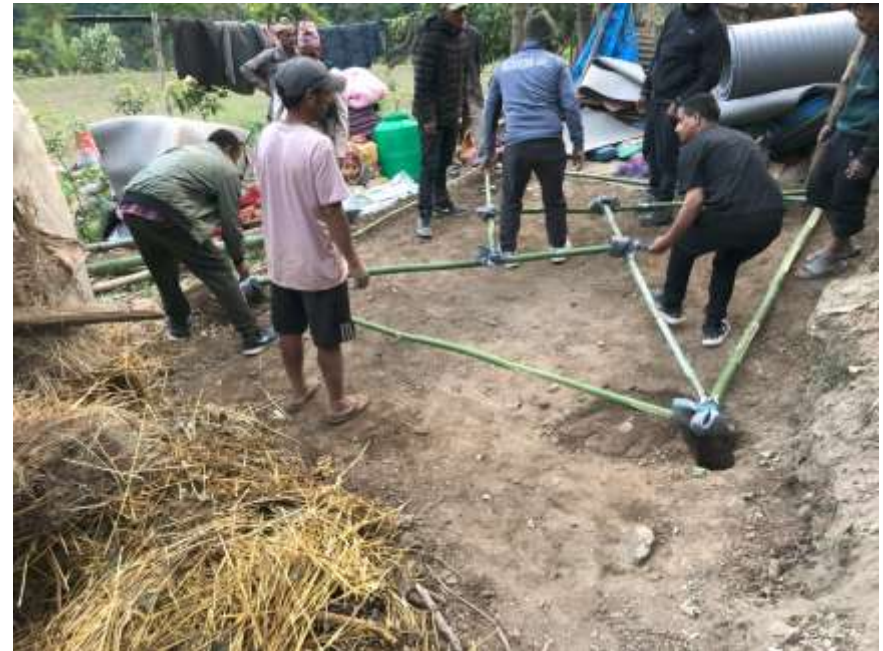
Digging the holes for the RSK four corner posts.

At midday the team set about building this first shelter with the resolve to finish the shelter for the family by nightfall. This was going to be difficult as the ground was very rocky to dig holes for the posts and the saws we brought were having difficulty cutting the sap heavy green bamboo. One of the community team was a carpenter and it was most helpful to make use of his skills using a curved machete to cut the slots and dowel holes at the top of the posts.

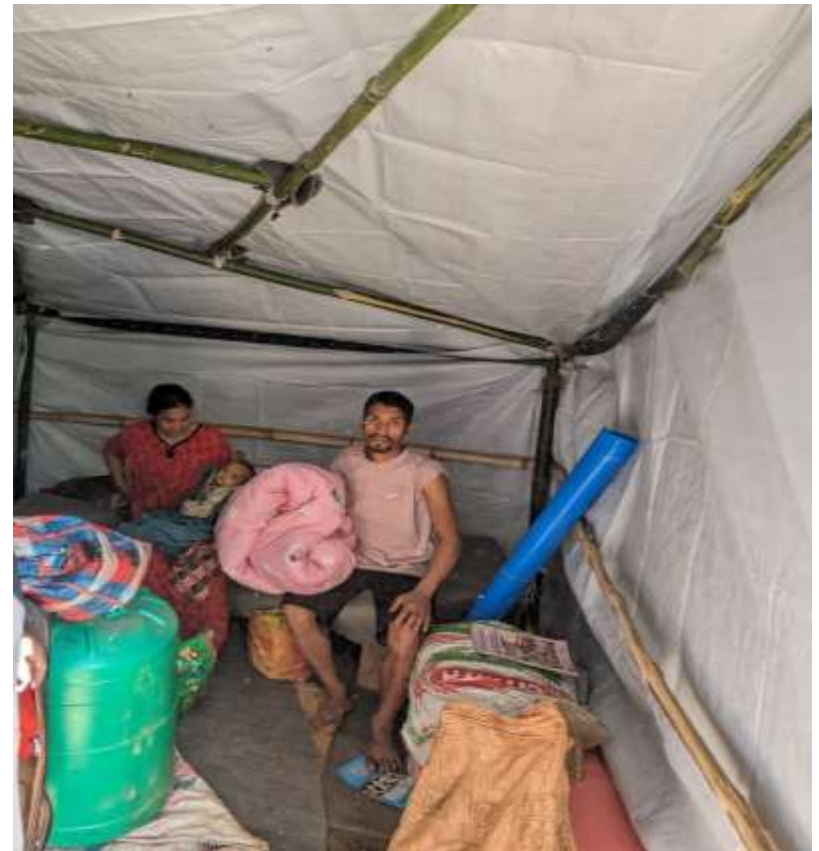
Mats on the ground for insulation as the first RSK shelter nears completion.

By mid afternoon the sun had long set behind the surrounding mountains and temperatures fell rapidly as the light faded. Working on in the darkness the team made the shelter secure enough for the family to use for the night and placed insulation mats on the floor.

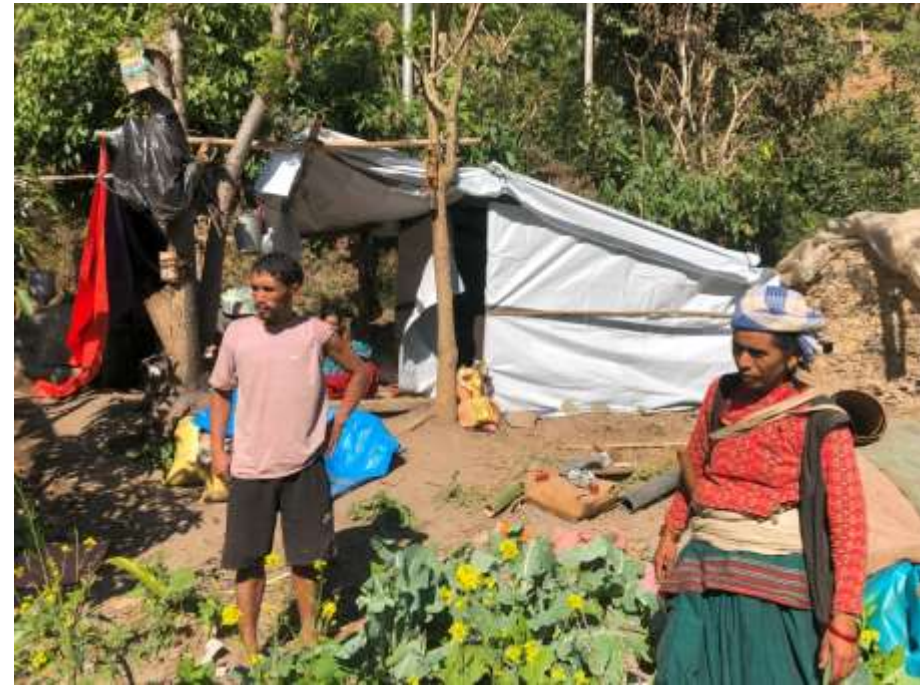
Front flap open to create a covered area for cooking.

We then returned to the first shelter to complete attaching the tarpaulins and to demonstrate how the front flap could be pulled open to create an awning during the day.

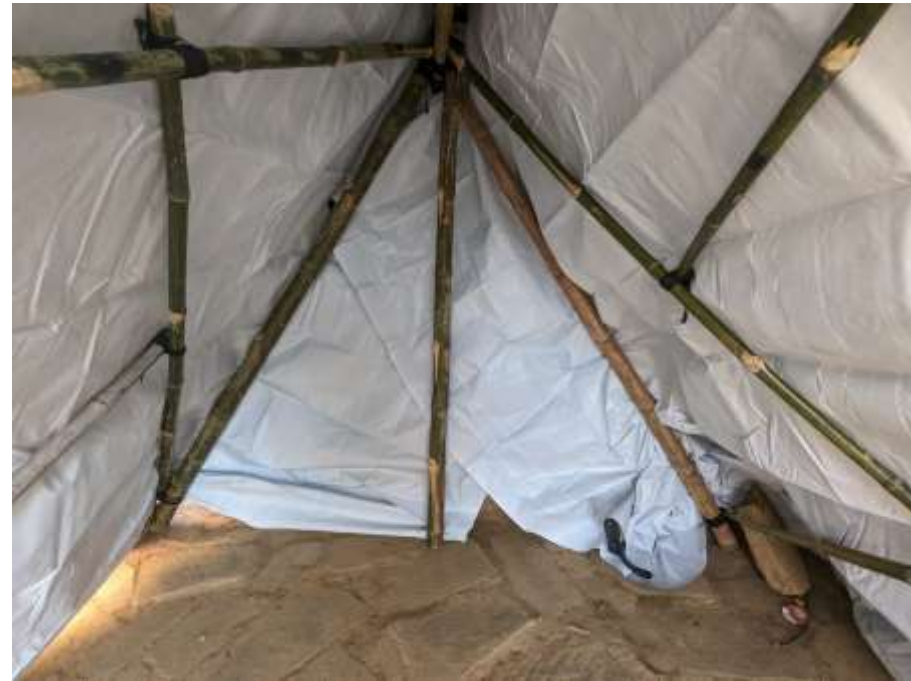
The team build a modified Urban RSK for themselves to sleep in.

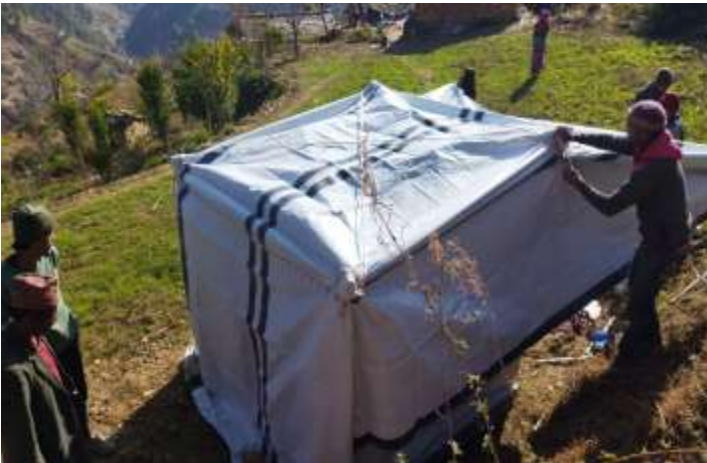
Building the reduced internal volume RSK shelter

Kushe was at a higher altitude, colder and more exposed than Nalgad. It was therefore decided to reduce the length of the central roof frame poles to 2.4 metres and thereby the size of the RSK shelters. The height of the lower support posts was also reduced to increase the roof incline .

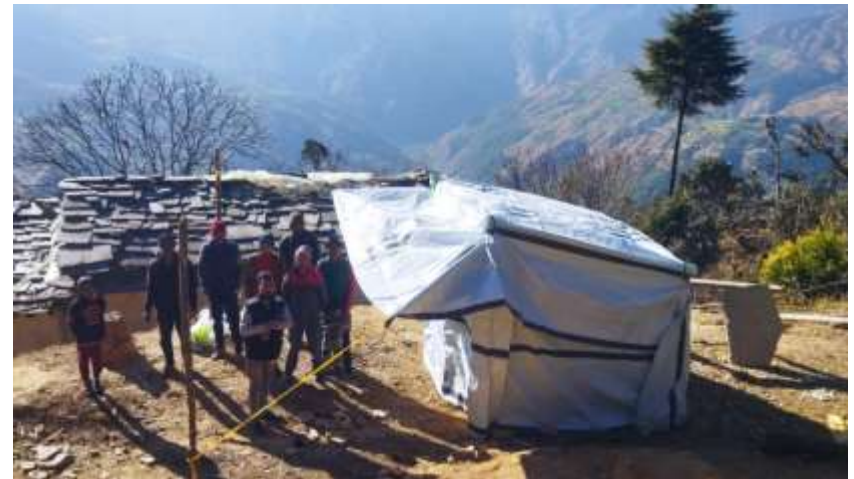
The modified Standard RSK shelter with increased roof incline.

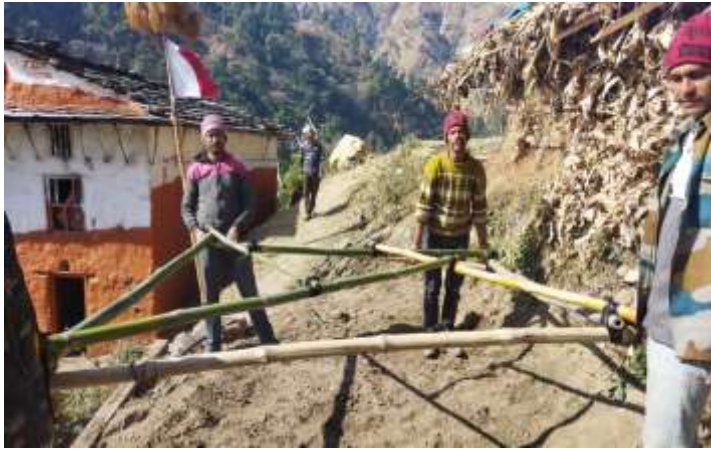
Carrying the roof frame to shelter site

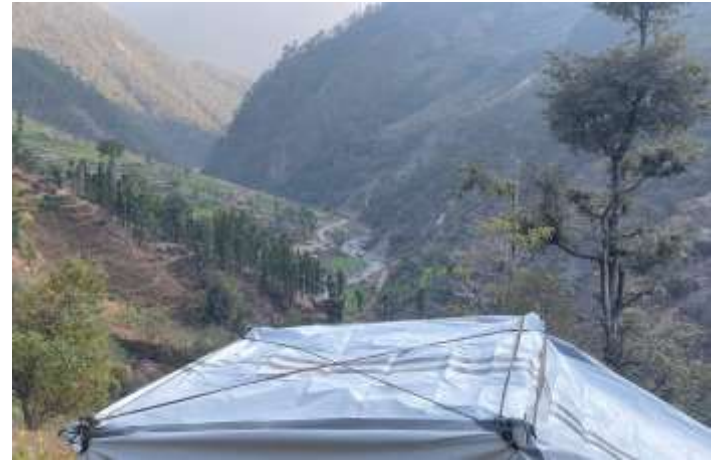
The roof frame in position

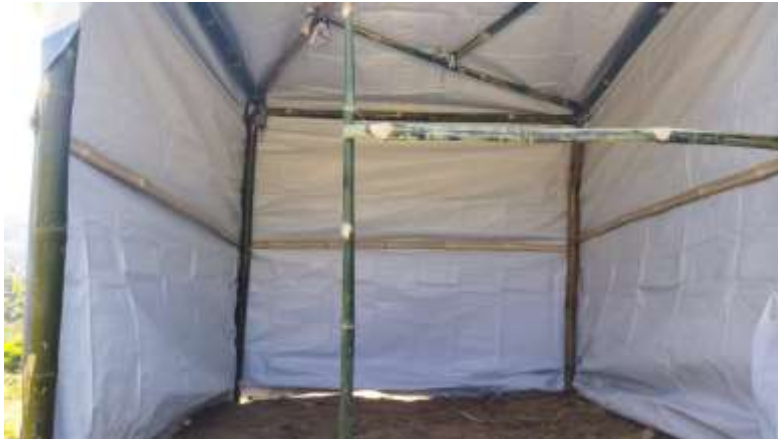
Inside of an RSK shelter being built

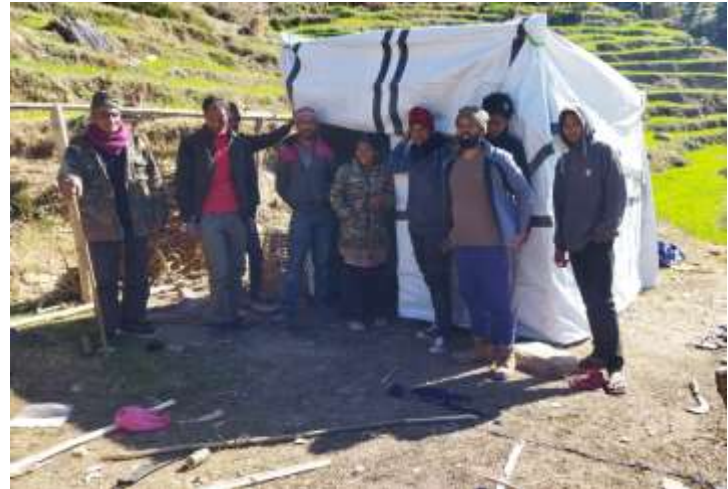
The reduced size RSK shelter
